# Ball mill maintenance

by Dr Devinder S Grewal, PE,  
Principia Engineering Inc, USA

## Cracked trunnions

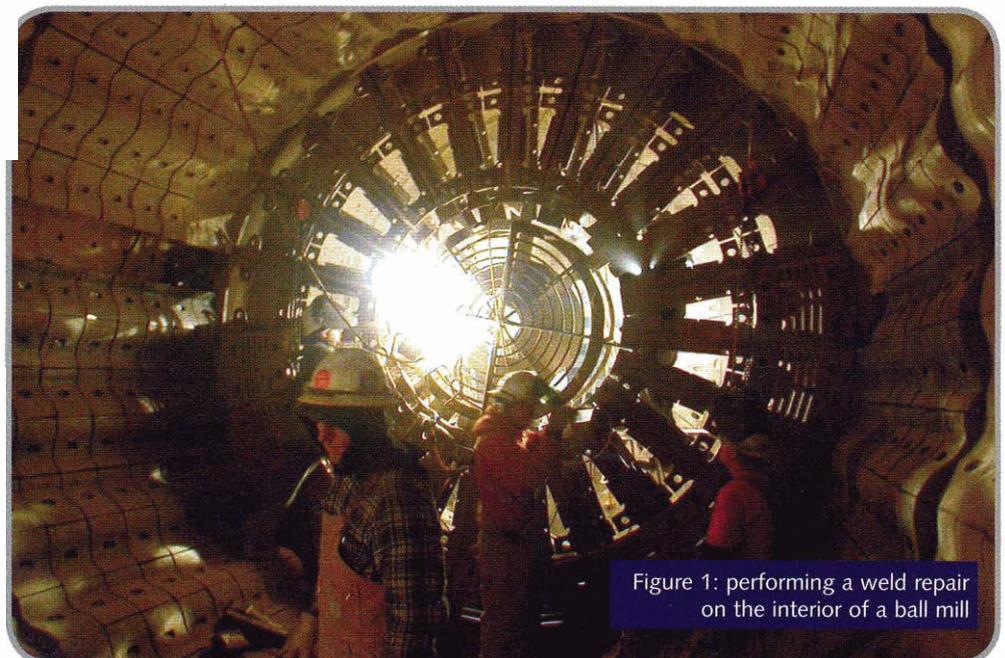
Figure 1: performing a weld repair on the interior of a ball mill

2. perform weld-repairs in-place on the trunnions to extend the service life

this option is reduced operating costs and perhaps greater product output over the life of the new mills. The repair option is only a temporary solution because it is virtually impossible to anneal the material and reduce the heat-affected-zone when the trunnion is welded in-place. The final option, to replace the trunnions with new ones is attractive as long as the trunnions can be manufactured locally at a reasonable cost.

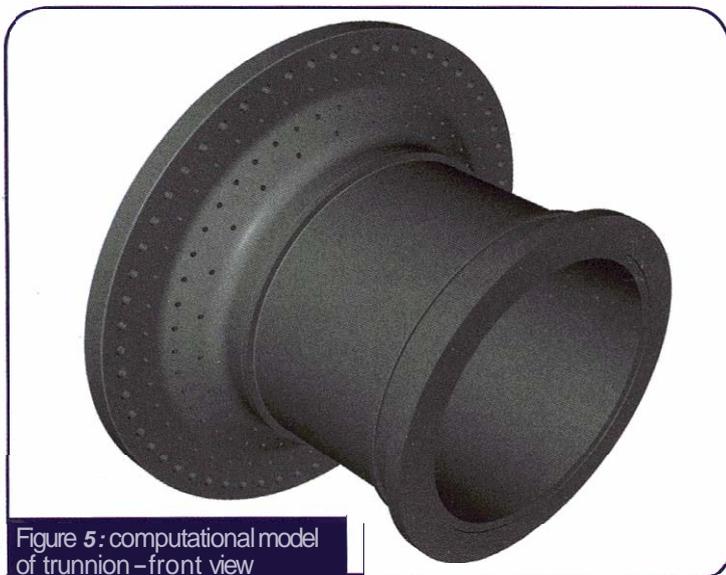
The original design calculations were not available so Principia had to reverse-engineer most of the design (see Figures 3, 5 and 6). This is a common issue when analysing legacy or obsolete equipment.

Figure 5: computational model of trunnion - front view

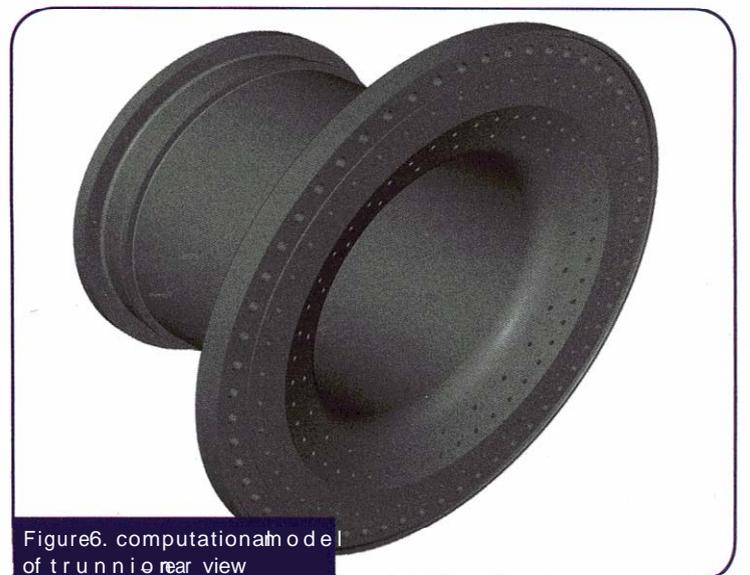
Figure 6: computational model of trunnion rear view
